Inland Empire Utilities Agency Asset Management Plan

Fiscal Year 2016/17

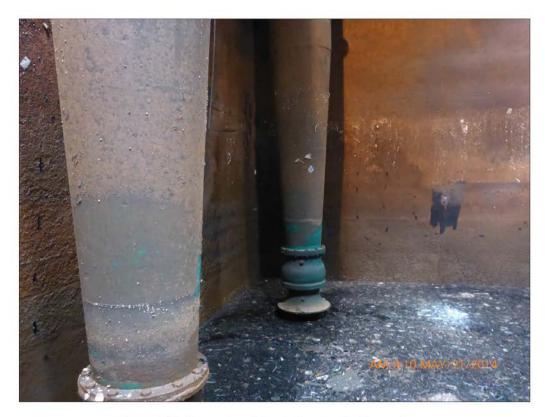
Figure 2 – Wall concrete condition in the wet well submerged zone $\,$

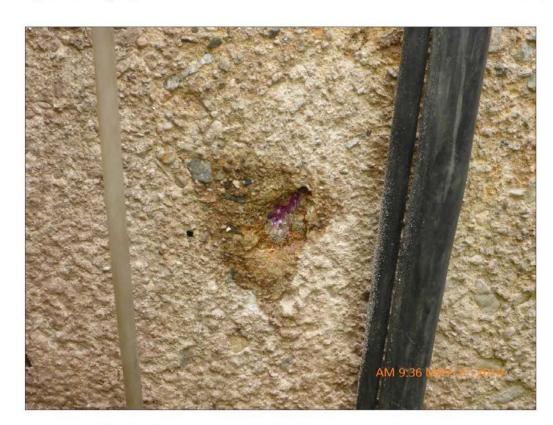
Figure 3 – Exposed aggregate and weakened concrete in wet well vapor space

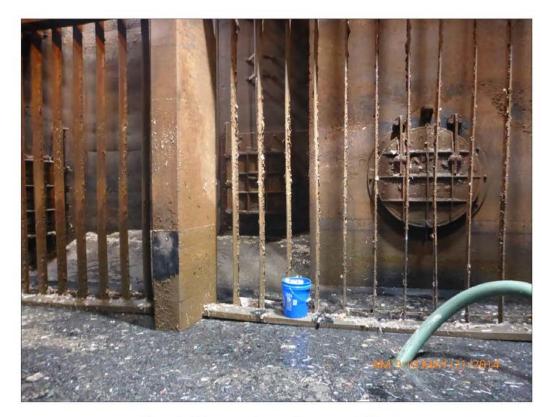
Figure 4 - Minor corrosion on valve cover and slide gates

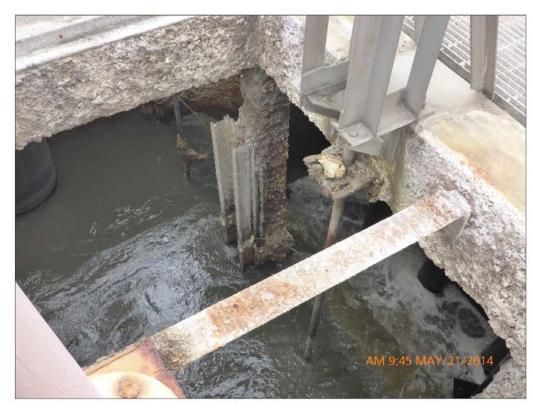
Figure 5 - Weakened concrete, exposed aggregate, and section loss

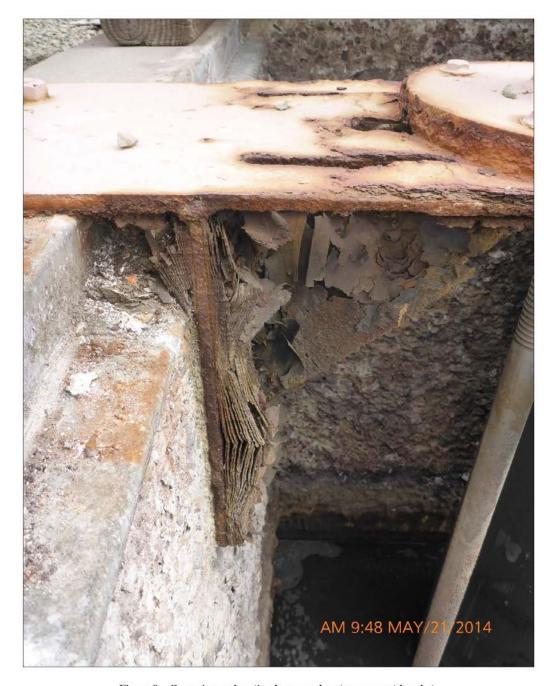
$Figure\ 8-Corrosion\ and\ section\ loss\ on\ valve\ stem\ support\ bracket$

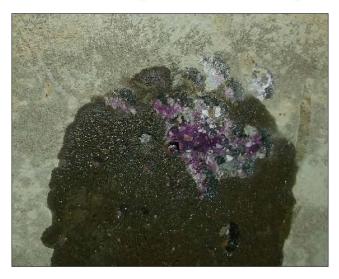
When performing the phenolphthalein test, 12 locations tested in the submerged zone produced a color change in the concrete (pH of 10-12) at a depth of less than 1/16-inch from the concrete surface, as shown in Figure 1. The shallow depth to high pH material and lack of roughening or spalling indicated that the concrete was in good condition in the submerged zone.

Figure 1 - Phenolphthalein test on the concrete shell

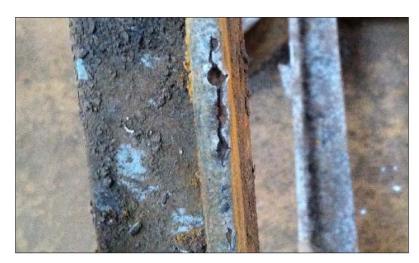
Figure 2 - Pitting of the steel where a rust tubercle had formed on the steel rake arm

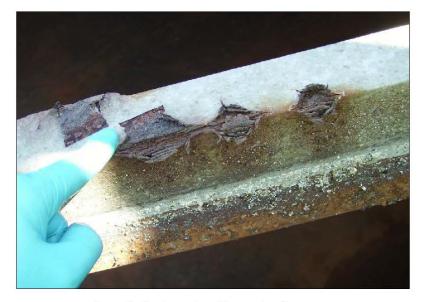
The skimmer arm that circulates above the wastewater line in the clarifier was found to be in poor condition. Significant rusting and metal loss in layers was observed along the skimmer arm, as shown in Figure 3. The observed metal loss was most likely a result of acid attack in the vapor space.

Figure 3 - Rusting and metal loss on the skimmer arm

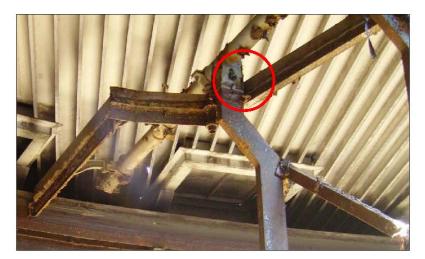
Figure 4 – Stainless steel fasteners in contact with carbon steel components of skimmer arm

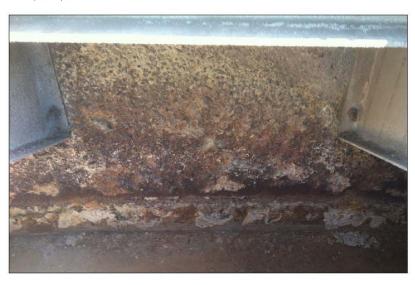
The effluent launder was found to be in poor condition. Concrete in the effluent launder was degraded and had exposed aggregate above the wastewater line, as shown in Figure 5. Phenolphthalein tests were not performed in these areas because they were not accessible. There was minor staining on the steel anchor bolts supporting the aluminum brackets for the hatches around the effluent launder. The observed degradation was most likely a result of acid attack in the vapor space.

Figure 5 - Condition of the concrete in the effluent launder vapor space of primary clarifier no. 1

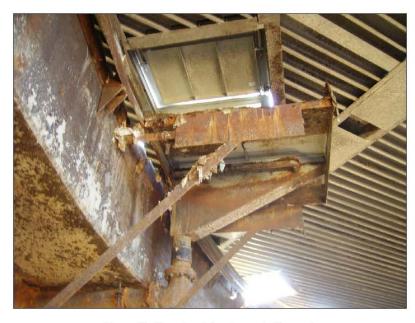
The scum trough and discharge pipe were found to be in similar poor condition. There was significant staining and corrosion on all components of the scum trough, as shown in Figure 6. UT and DFT measurements were not taken because it was inaccessible from the clarifier floor and roof hatches. The support arm anchor bolts for the scum trough were observed to have moderate staining and surface rusting.

Figure 6 - Scum trough in primary clarifier no. 1

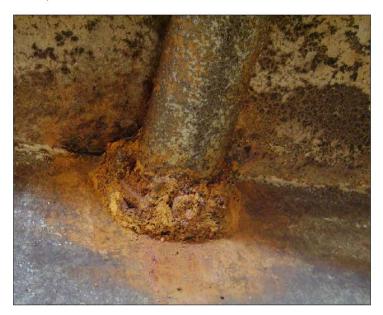
The scum trough discharge pipe was observed to be in similar poor condition as the scum trough. There was significant corrosion product at the shell wall and pipe interface and on the pipe joints, as shown in Figure 7. The nuts and bolts were not visible because of the large amount of corrosion product at the wall interface.

Figure 7 - Corrosion product at the scum trough discharge pipe and shell wall interface

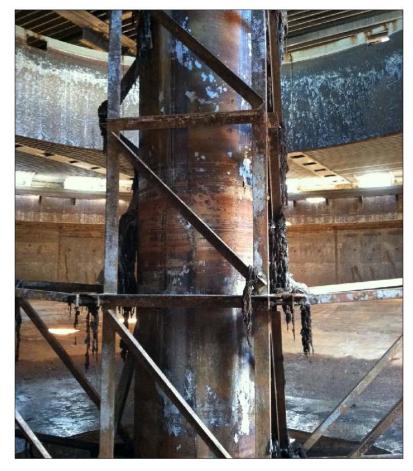
The center column was found to be in fair condition. Staining, rusting, and peeling of the coating were visible, as shown in Figure 8. The staining could be due to adhesion of contaminants and solids in the wastewater. The coating degradation was most likely a result of mechanical abrasion caused by agitated grit in the wastewater stream.

Figure 8 – Staining and peeling of the coating on the center column

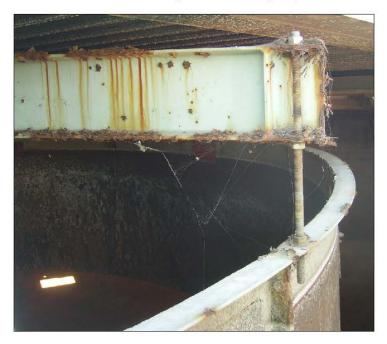
The inlet well and assembly components were found to be in poor condition. The inlet well had staining and rusting of the steel and delamination and peeling of the coating. The top beam attached to the inlet well by a threaded rod was observed to have significant rusting and metal loss in layers along the top and bottom flanges, as shown in Figure 9. The most likely damage mechanism was acid attack on the steel components in the vapor space.

Figure 9 - Rusting and metal loss on the center column baffle assembly

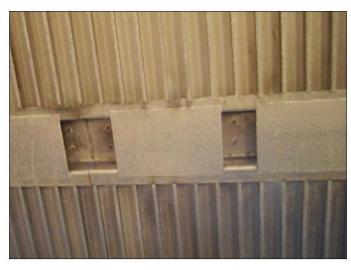
The aluminum roof and support beams were found to be in good condition. Only minor staining on the roof and beams was observed during the inspection, as shown in Figure 10. Fasteners, brackets, and support beams were in good condition. The aluminum roof support beams were observed to be in direct contact with the clarifier wall concrete.

Figure 10 - Aluminum roof and support beam

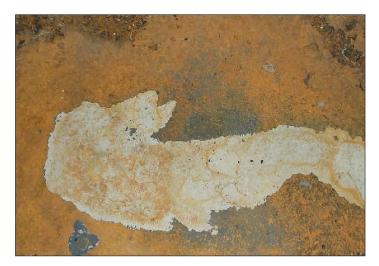
No voids were detected in the concrete walls by sounding. Crack locations in the walls and floor were tested and found to be solid. Delamination and peeling of the coal tar epoxy coating was observed on the shell floor, as shown in Figure 11. The degradation of the coating was most likely a result of mechanical abrasion from the rake arm.

Figure 11 - Degradation of the coal tar epoxy coating on the shell floor

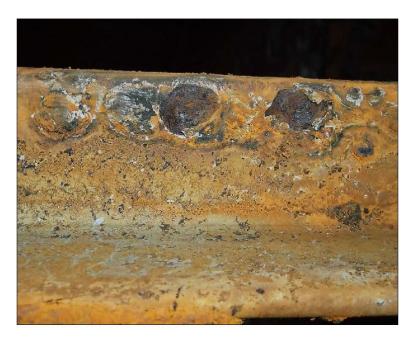
Figure 12 - Corrosion on the steel rake arm

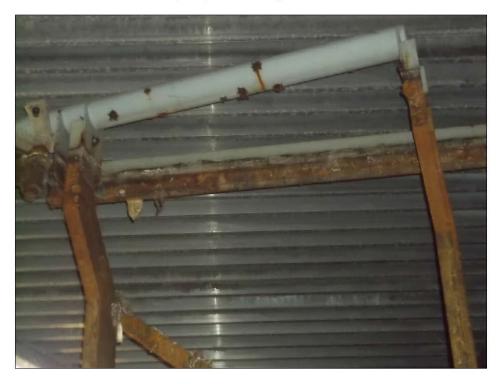
The skimmer arm was found to be in poor condition. In the submerged zone general corrosion was observed along the full length of the skimmer arm from the inlet well to the outer end. Spot corrosion above the wastewater line was also observed, which can be attributed to acid attack in the vapor space. See Figure 13.

Figure 13 – Skimmer arm corrosion

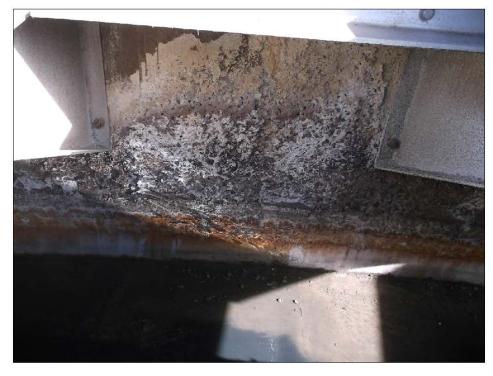
Concrete in the effluent launder was found to be in poor condition. Exposed aggregate and spalling of the concrete was observed in the areas above the wastewater line, as shown in Figure 14. Phenolphthalein tests were not performed in these areas because they were not accessible. There was staining and surface rusting on the anchor bolts supporting the brackets for the roof hatches around the effluent launder. The observed degradation was most likely a result of acid attack in the vapor space.

Figure 14 - Exposed aggregate and spalling of the concrete in the effluent launder

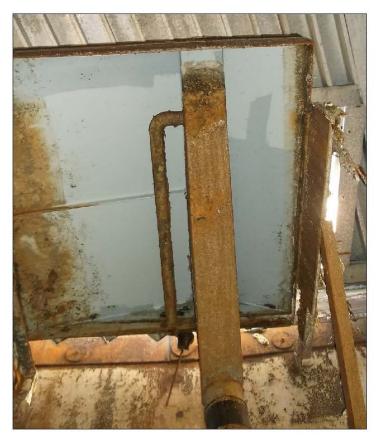
The scum trough was found to be in poor condition. There was staining and general corrosion on all components of the scum trough, as shown in Figure 15. The support arm stainless steel anchor bolts for the scum trough were observed to have moderate staining and surface rusting. UT and DFT measurements were not taken because it was inaccessible from the clarifier floor and roof hatches.

Figure 15 - Corrosion of the scum trough

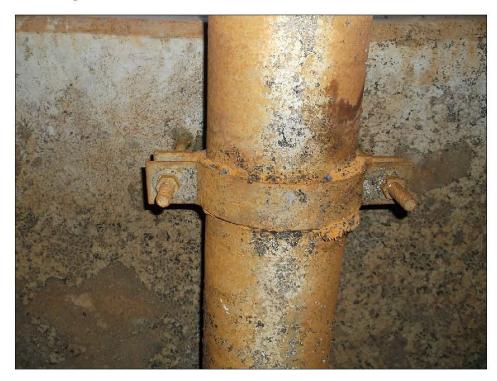
The scum trough discharge pipe was observed to be in similar poor condition as the scum trough. General corrosion and staining along the discharge pipe was observed. There was also significant corrosion product at the shell wall and pipe interface, pipe joints, and anchor bracket, as shown in Figure 16.

Figure 16 – Significant corrosion on the discharge pipe

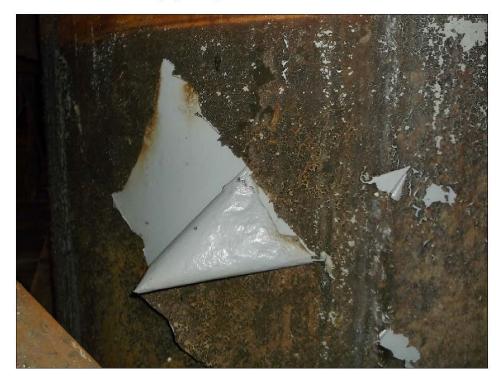
The center column was found to be in fair condition. Staining, rusting, delamination and peeling of the coating were visible, as shown in Figure 17. The staining could be due to adhesion of contaminants and solids in the wastewater. The coating degradation was most likely a result of mechanical abrasion caused by agitated grit in the wastewater stream.

Figure 17 - Delamination and peeling of the coating on the center column

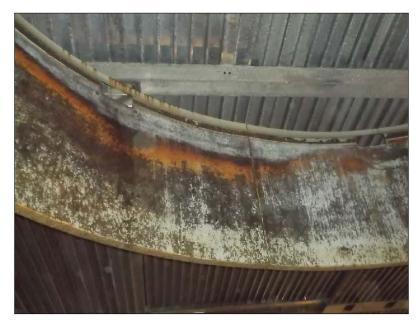
The inlet well was found to be in poor condition. There was rusting, staining and delamination and peeling of the coating below the wastewater line, as shown in Figure 18. Above the wastewater line, rusting and metal loss of exposed steel was observed. The observed rusting and metal loss was most likely due to acid attack in the vapor space. Galvanic corrosion was observed at the top of the inlet well baffle adjacent to the stainless steel fasteners connecting baffle sections.

Figure 18 - Staining and corrosion on the inlet well

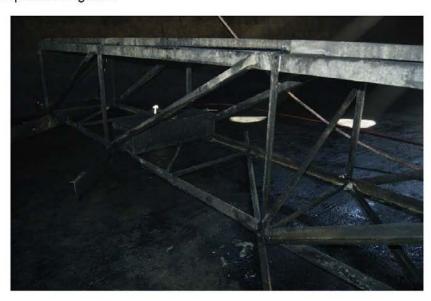
The east squeegee rake arm is constructed of epoxy-coated carbon steel. No galvanic anodes were observed on the rake arm to provide cathodic protection. The east rake arm is depicted in Figure 1.

Figure 1 - Squeegee Rake Arm (East)

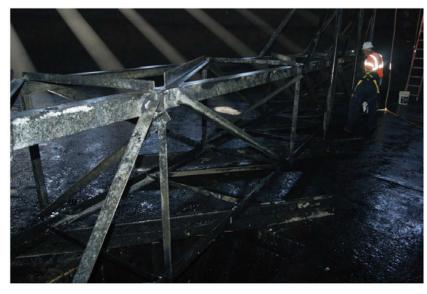
The west sludge rake arm is also constructed of epoxy-coated carbon steel. No galvanic anodes were observed on the rake arm to provide cathodic protection. The west rake arm is depicted in Figure 2.

Figure 2 - Sludge Rake Arm (West)

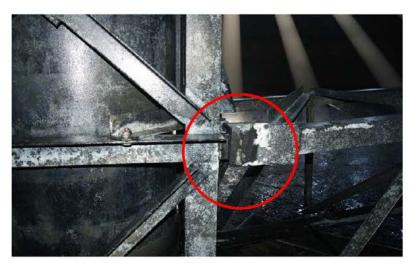
The rake arms were connected to the central support assembly by angle iron braces. Two small areas of corrosion in the weldment at the intersection of the angle braces and the rake arm were noted. See Figure 3 below.

Figure 3 - Weldment corrosion at the connection between angle braces

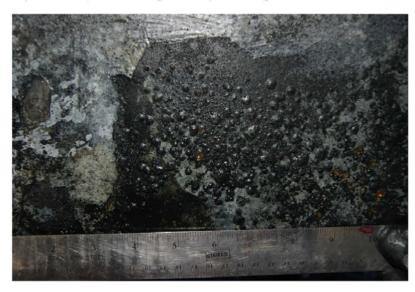
The east plate brace supports the east squeegee rake arm from the central support assembly. Blistering of the coated surface area was noted on the 10-1/2" X 6-1/4" flat plate brace (south side, outer facing surface). See Figure 4 below.

Figure 4 - Coating blistering on flat plate brace

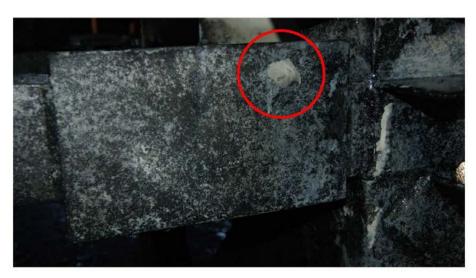
The west plate brace supports the west squeegee rake arm from the central support assembly. Coating delamination was noted on the 10-1/2" X 6-1/4" flat plate brace (south side, outer facing surface). See Figure 5 below.

Figure 5 - Coating delamination on flat plate brace

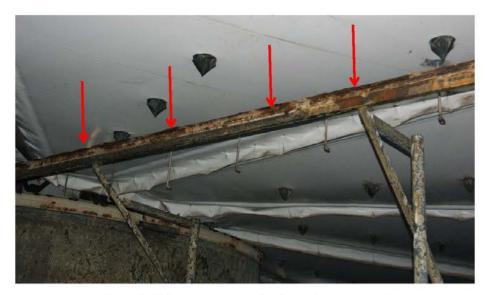
Corrosion was observed along the full length of the skimmer arm from the inlet well to the outer end. Refer to Figures 6 and 7 below.

Figure 6 - Skimmer arm corrosion (central support end)

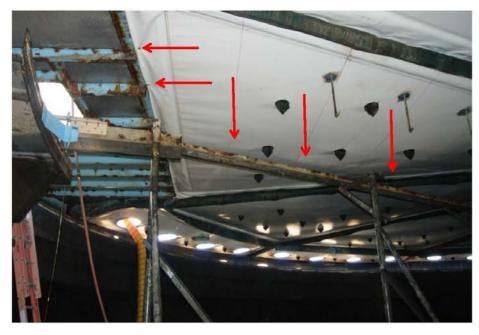
Figure 7 - Skimmer arm corrosion (assembly outer end)

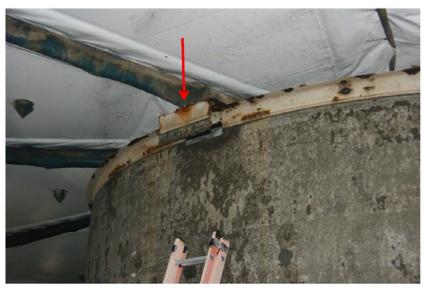
Corrosion was observed on the inlet well angle-iron brace and the influent baffles. See Figure 8 below.

Figure 8 - Inlet well (north side)

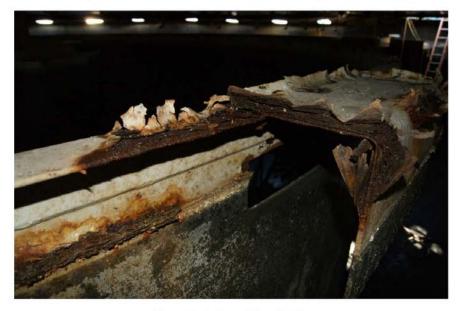
Extensive coating degradation was observed on the inlet well angle iron brace. Corrosion of the exposed steel was also severe. Refer to Figure 9 and Figure 10 below.

Figure 9 - Inlet well flow baffle

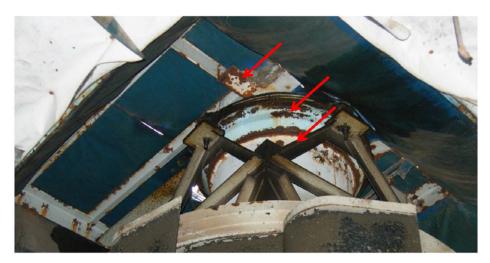
The carbon steel surfaces of the rake motor and drive assembly that are coated with the generic epoxy material showed signs of general corrosion. See Figure 11 below.

Figure 11 - Drive motor assembly showing signs of general corrosion

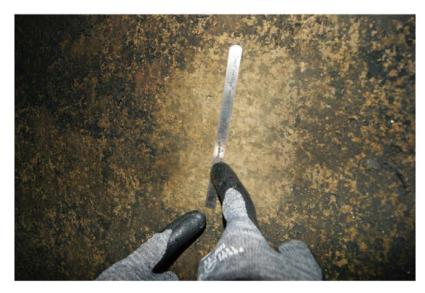
A visual assessment of the tank wall was performed in order to locate any areas of degraded concrete. During the visual observations of the submerged concrete it was documented that all concrete surfaces were covered with a film of typical waste residue. Once the film residue was removed by means of scraping, the concrete surface was found to be of a smooth surface with no exposed aggregate or other signs of degradation. See Figure 12 below.

Figure 12 - Typical tank wall condition
