Inland Empire Utilities Agency

**MEETING
OF THE
BOARD OF DIRECTORS**

Non-Reclaimable Wastewater System FY 2014/15 Proposed Rates

Asset Management Presentation

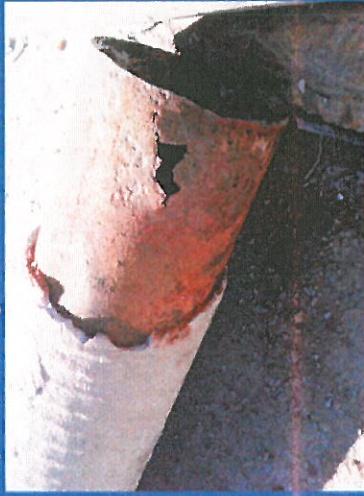
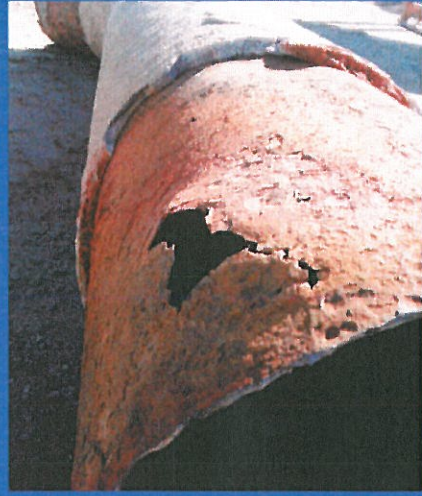
RP-1 Recycled Water Pipeline
Break

Pipe leakage due to corrosion

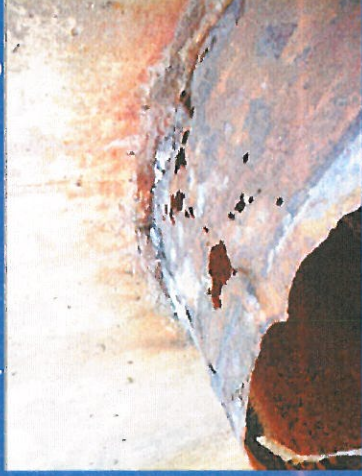
RP-1 Primary Effluent Pipe
Failure

Pipe External Damage

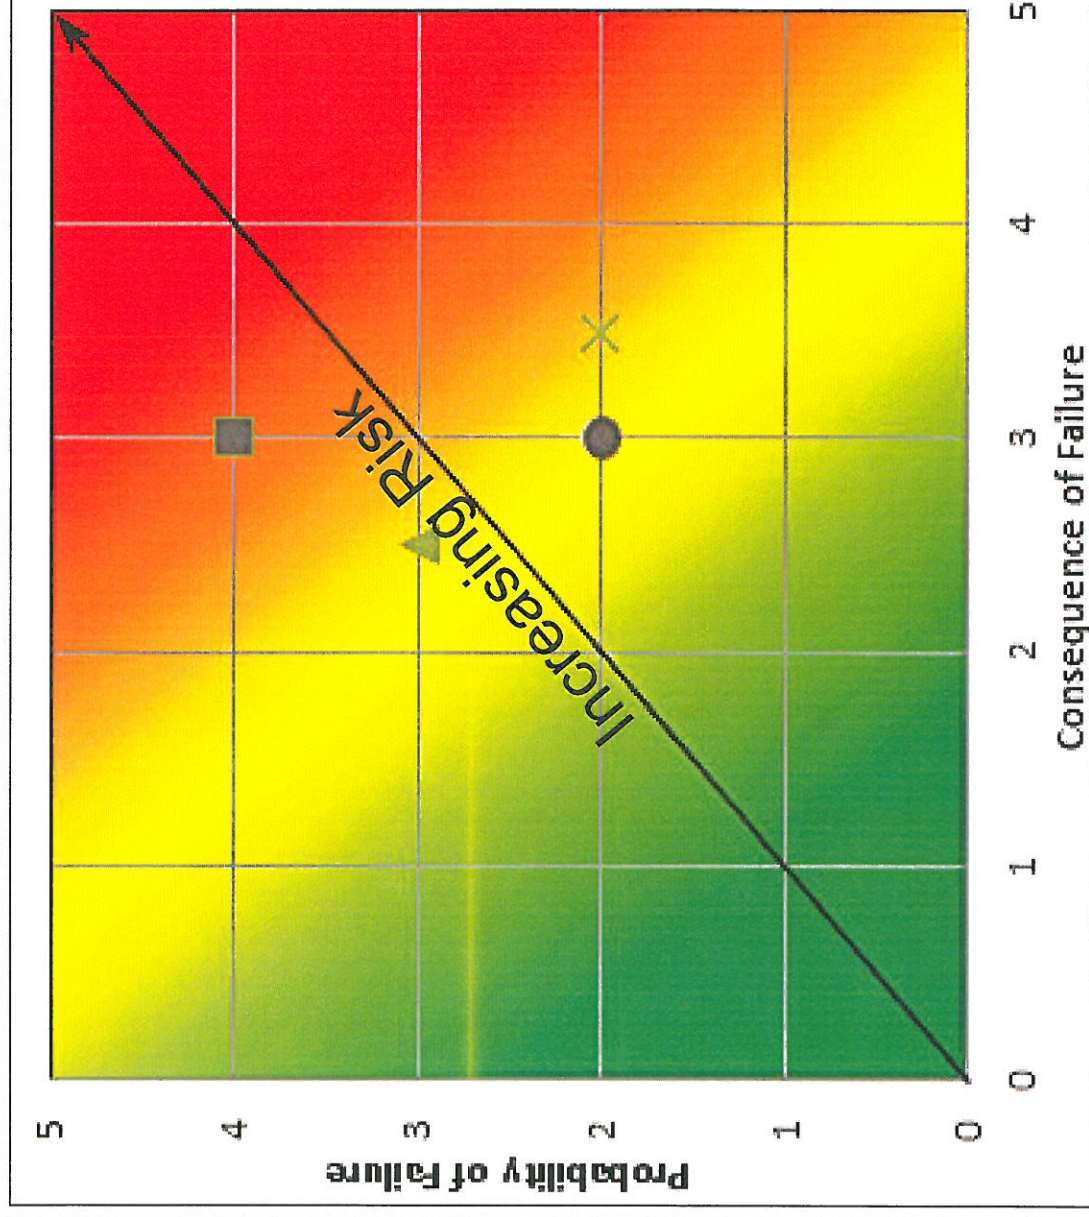
Risk = (Probability of Failure) x (Consequence of Failure)

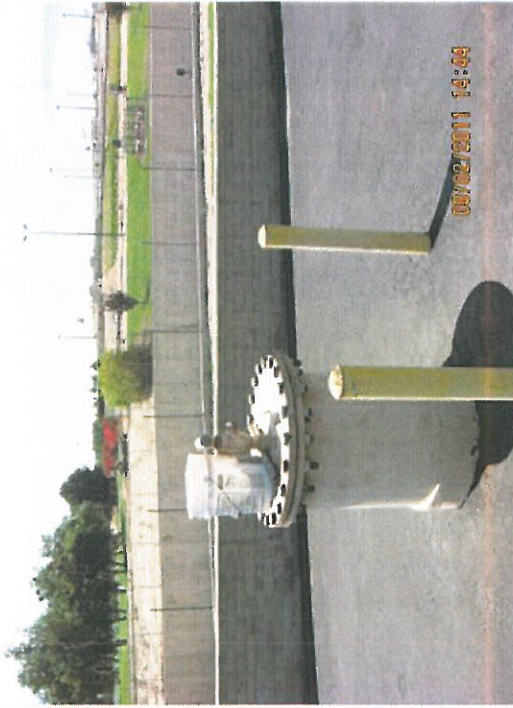
RP-1 Secondary Effluent Pipe Condition Assessment

- **35-year-old cement mortar-lined & coated 60" Pipe**
- **Risk exposure**
 - Probability of Failure: High
 - Consequence of Failure: High
- **Inspection results**
 - Pipe in good condition
 - Expected to last another 30 years

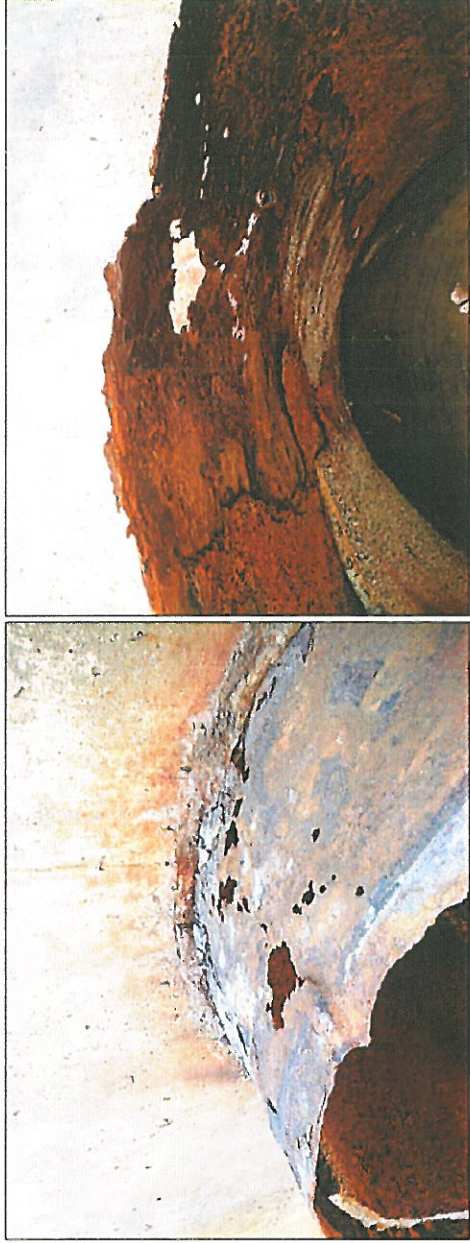
Figure 3 - Severe corrosion of welded steel cylinder at bladder valve vault pipe access point

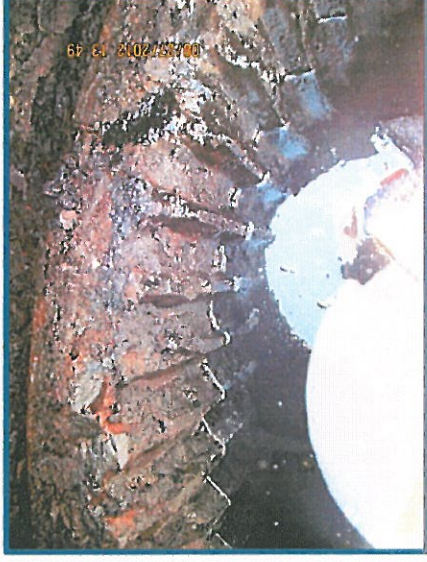
Clarifier drive main gear condition

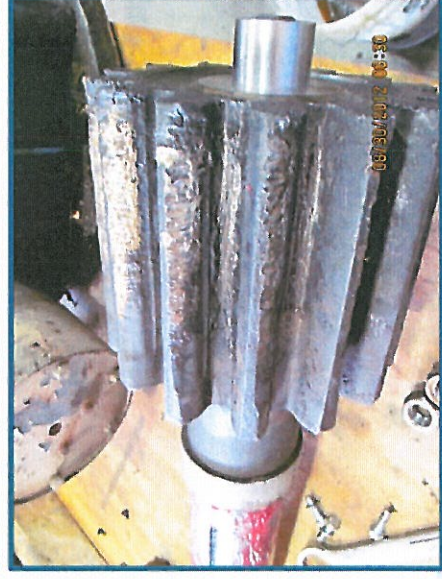
Clarifier drive pinion gear condition

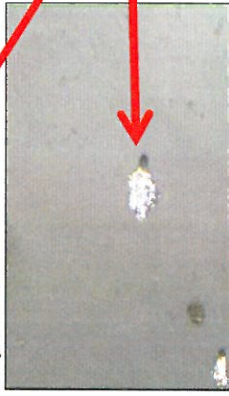
Image # 1 500x

Bearing wear particle was detected from lube oil samples

This image illustrates steel bearing wear.

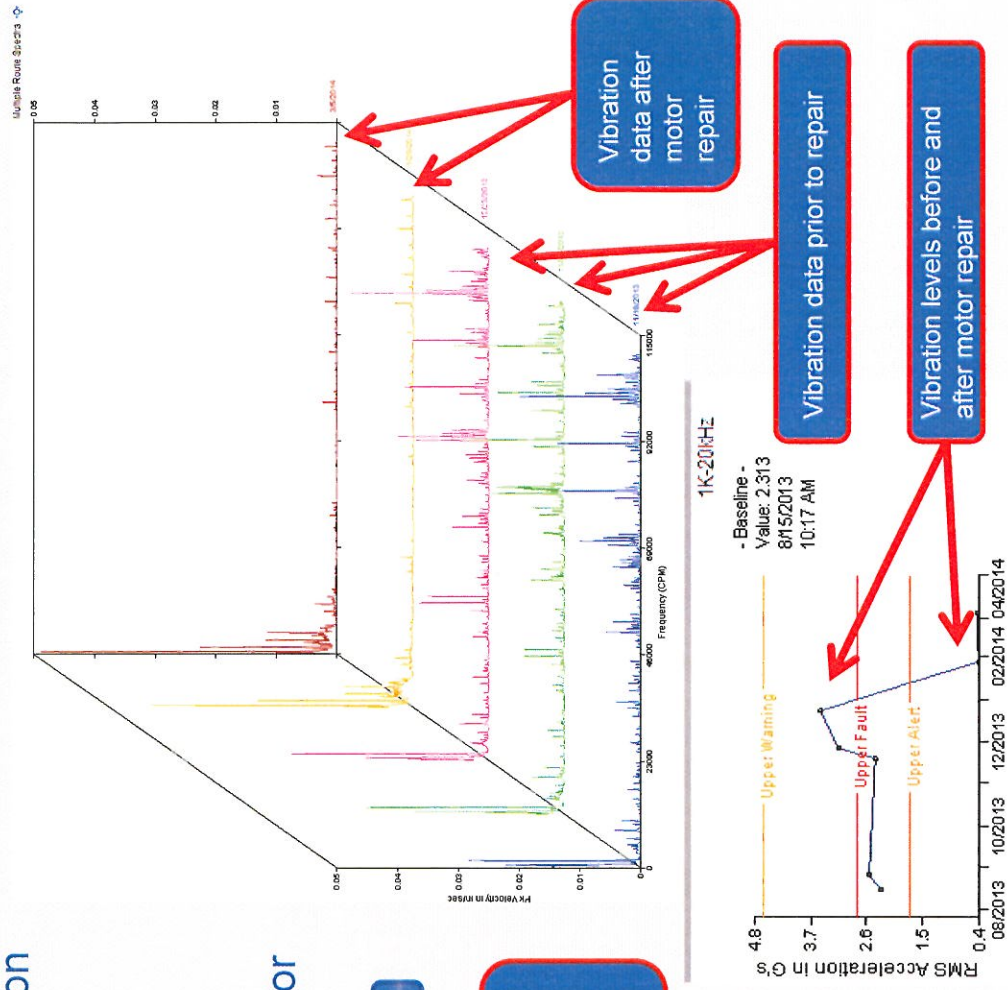
Bearing wear detected from vibration analysis

Image of vibration report
