Inland Empire Utilities Agency Asset Management Plan

Fiscal Year 2016/17

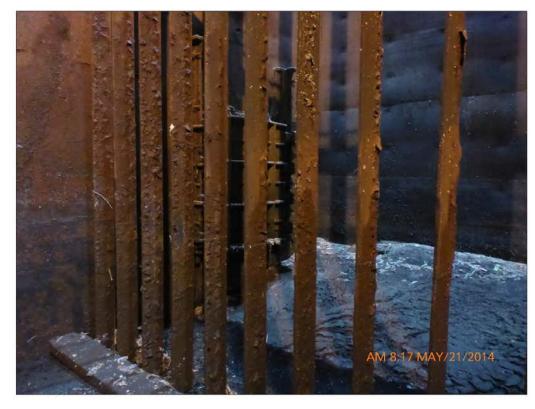
Both systems A and B were observed to be in similar condition. Coating failure was observed on the steel bar screen structure, as shown in Figure 1. Surface rusting was classified as spot rusting per ASTM D610. Individual members varied from rust grades 4-S (3-10% spot rusting) to 1-S (33-50% spot rusting). The steel components in System B, however, appeared to be in satisfactory condition under the coating with no visible section loss and relatively minor corrosion. Some pitting was observed on the vertical steel bars in System A near the inlet pipe.

Figure 1 - Coating failure on steel bar screen

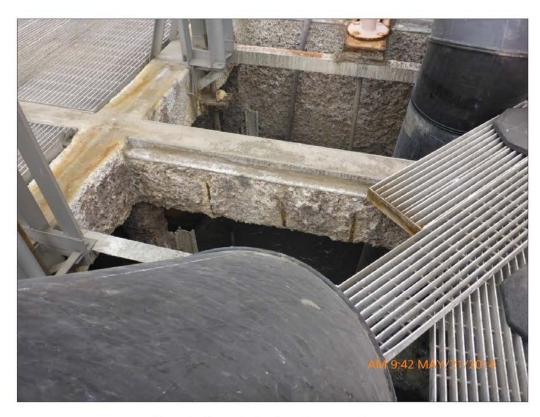
The splitter box was found to be in a distressed condition with evidence of severe acid attack on concrete and steel components. Weakened concrete, exposed aggregate, and section loss were observed on the concrete walls, center column, and grating concrete support beams, as shown in Figure 5. Exposed steel reinforcing bars were visible in the walls, column, and beams, as shown in Figure 6.

Figure 6 – Exposed rebar in grating support beam

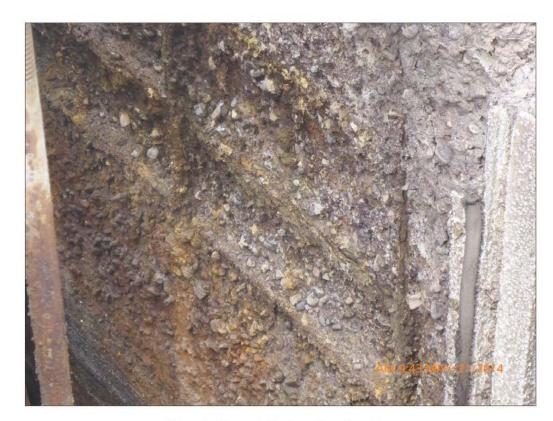
Based on an assumed cover depth of at least 3 inches, the concrete loss was estimated to be in excess of 4 inches at the worst locations, as shown in Figure 7. Site operations staff reported that

Figure 7 – Exposed rebar in wall of splitter box

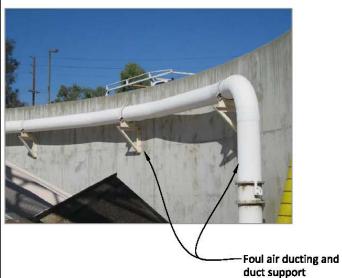
Odor Control System - 1

Foul air draw ducting and and the expansion bellow appear to be in good condition. The connection bolts have insignificant amount of surface corrosion

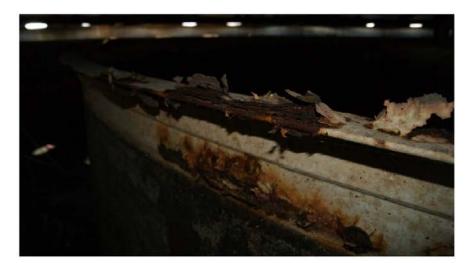
Figure 10 - Inlet well support ring

Extensive coating degradation was observed on the inlet well angle iron brace. Corrosion of the exposed steel was also severe. Refer to Figure 9 and Figure 10 below.
